BOEING
STRESS
CORROSION
TESTING
OF HIGH STRENGTH
STEELS

INVESTIGATION OF SUSCEPTIBILITY OF HIGH STRENGTH MARTENSITIC STEEL
ALLOYS TO STRESS CORROSION

TECHNICAL DOCUMENTARY REPORT NO. ASD-TDR-62-876
September 1962

(Prepared under Contract No. AF 33(616)-7839 by The Boeing Company,
Transport Division, Renton, Washington; Gary A. Dreyer, Author)

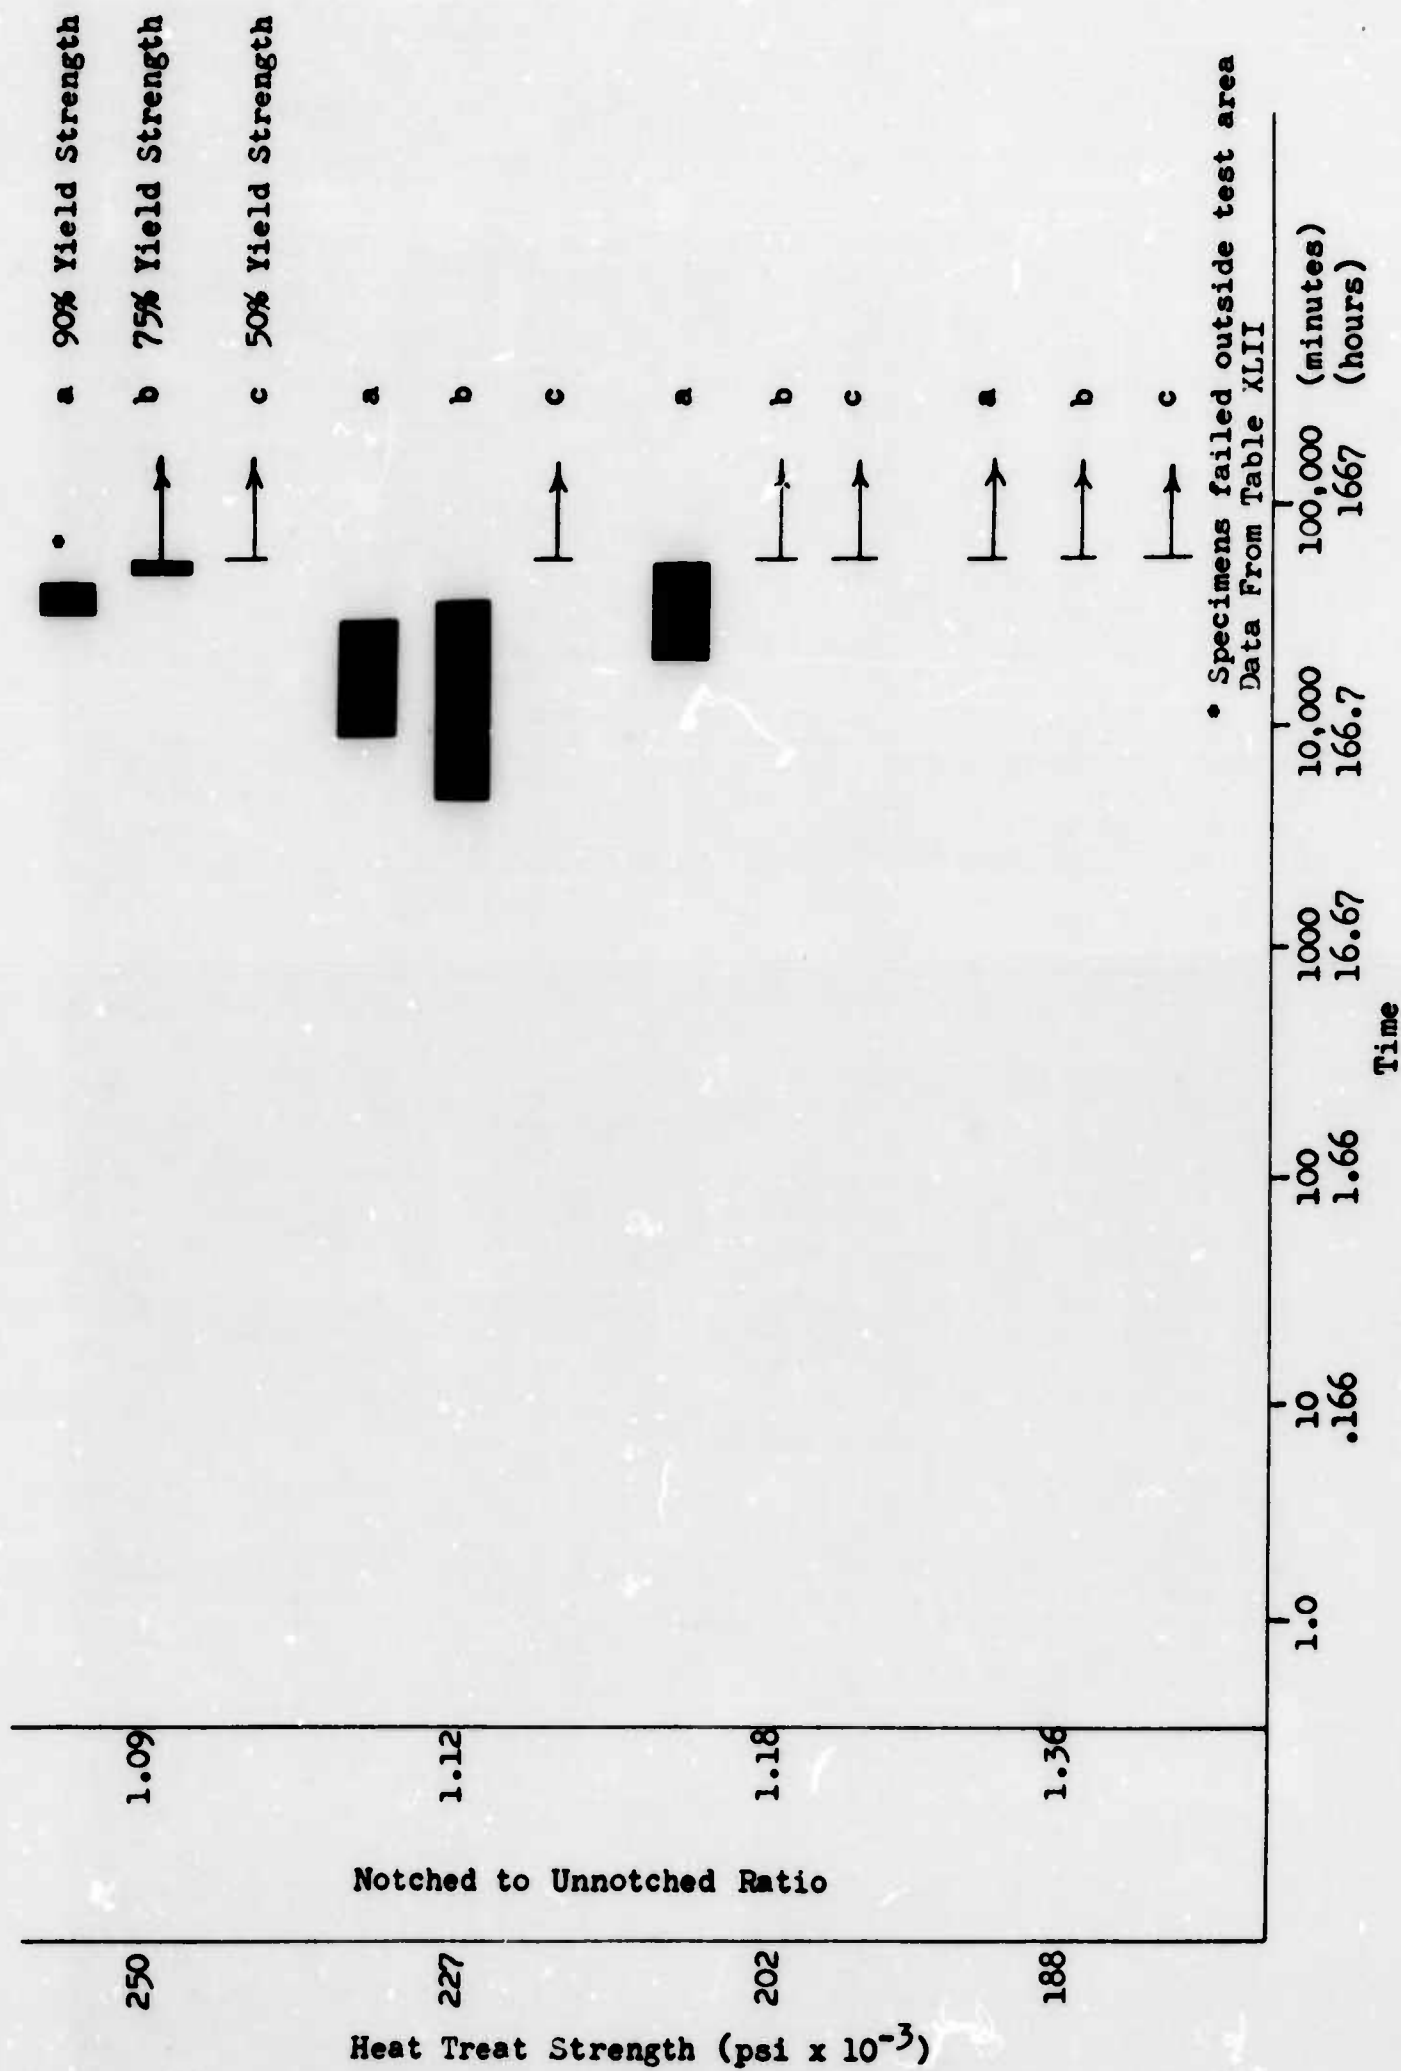
FIGURE 50. Range of Failure Times of 4330M (Billet R)

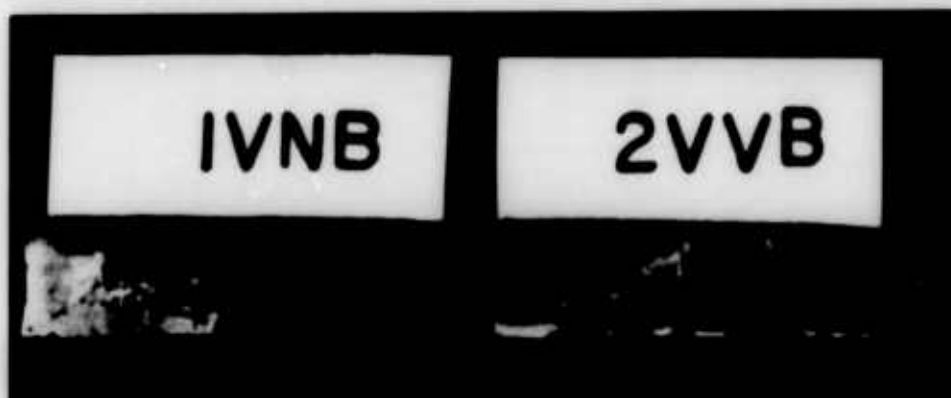
FIGURE 52
Fracture Faces of Air Melt and Vacuum Melt 4330M Specimens
225,000 psi Strength

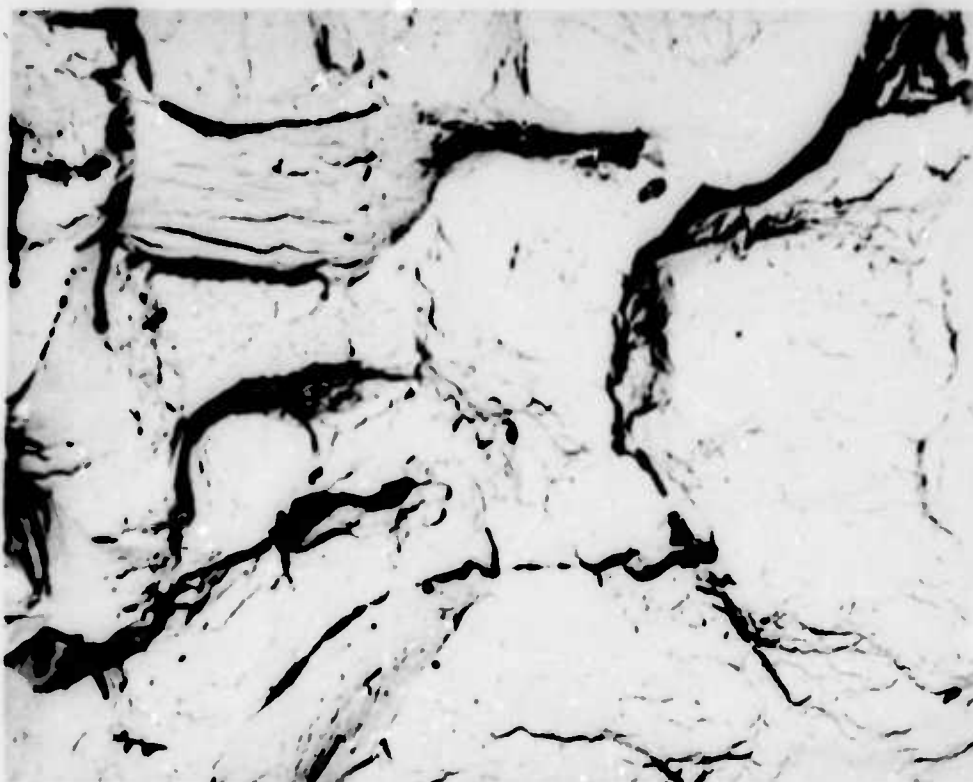
FIGURE 54
Electron Micrograph of Fracture Origin of 21N. 4340 (Martempered)
269,000 psi Heat Treat Strength 5800X

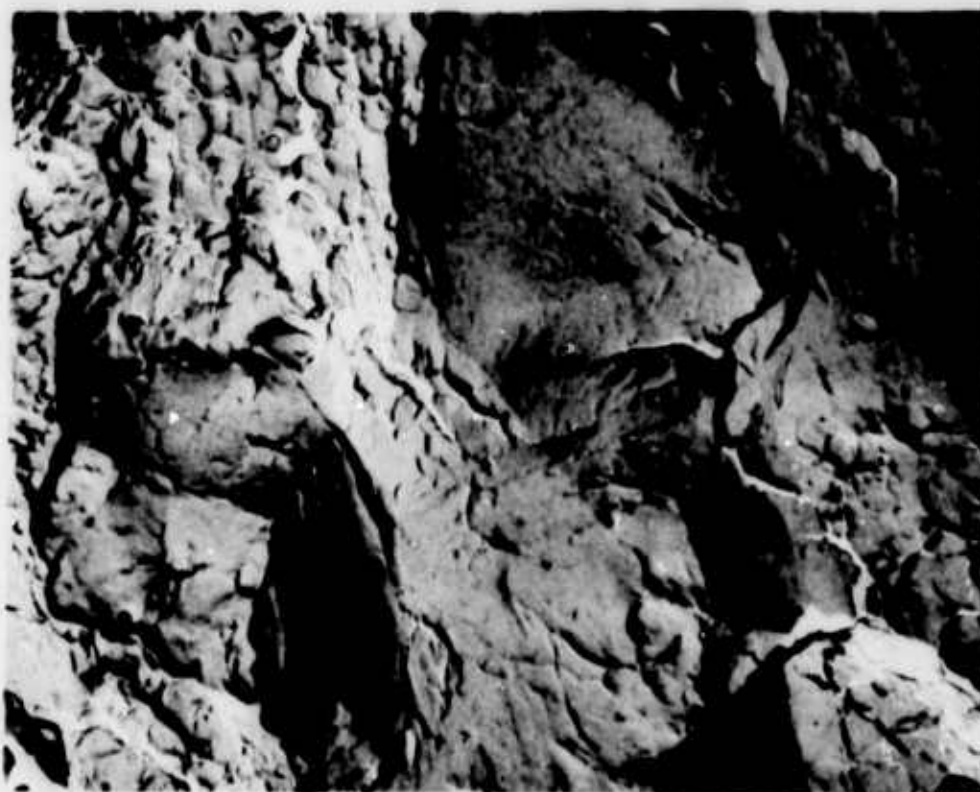
FIGURE 55
Electron Micrograph of Hydrogen Embrittlement Failure 4340
269,000 - 280,000 psi Heat Treat Strength Range
4600X

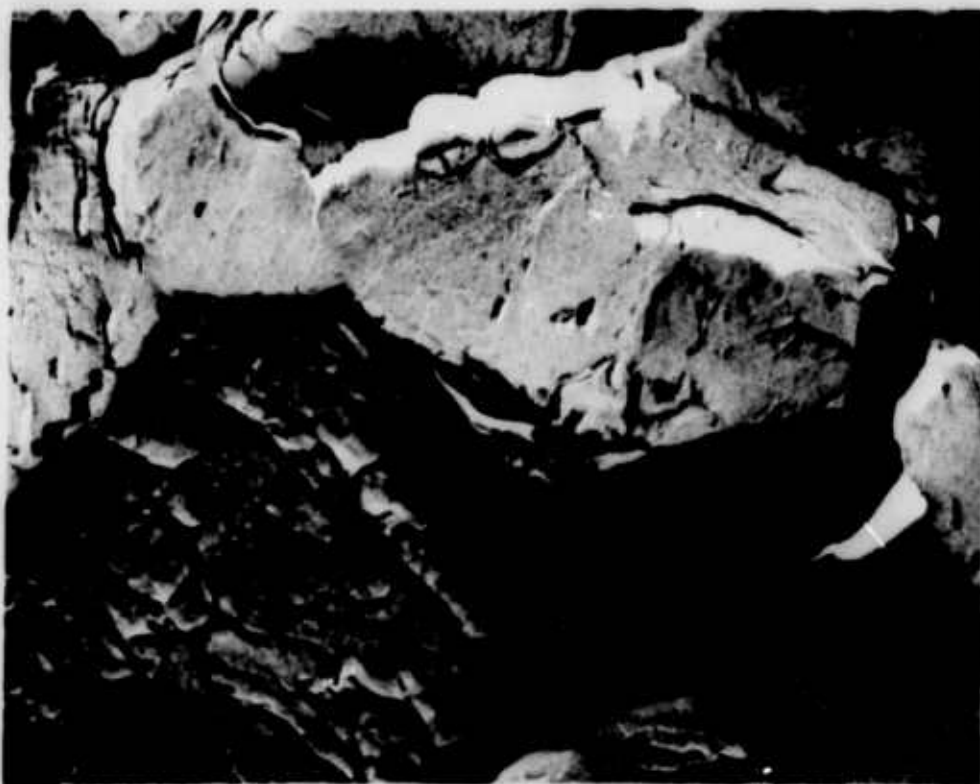
FIGURE 56
Electron Micrograph of Stress Corrosion Failure.
Specimen 3M 4340 280,000 psi Heat Treat Strength 8700X

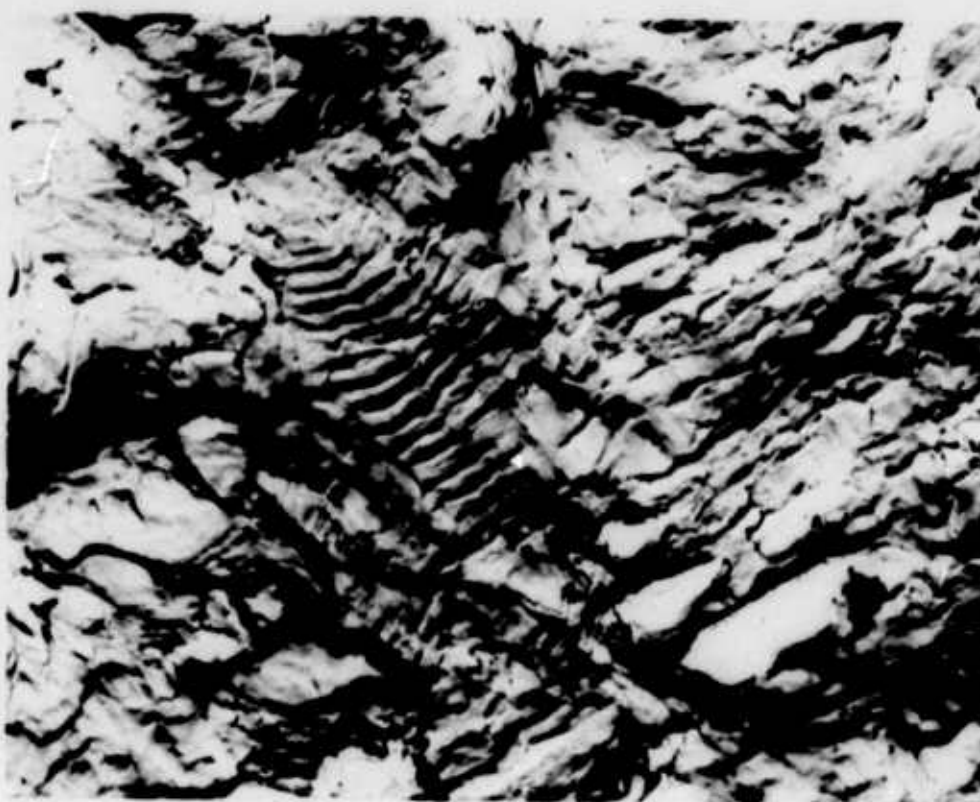
FIGURE 57
Electron Micrograph of Fatigue Failure.
4330M 220,000-240,000 psi Heat Treat Strength Range 6600X

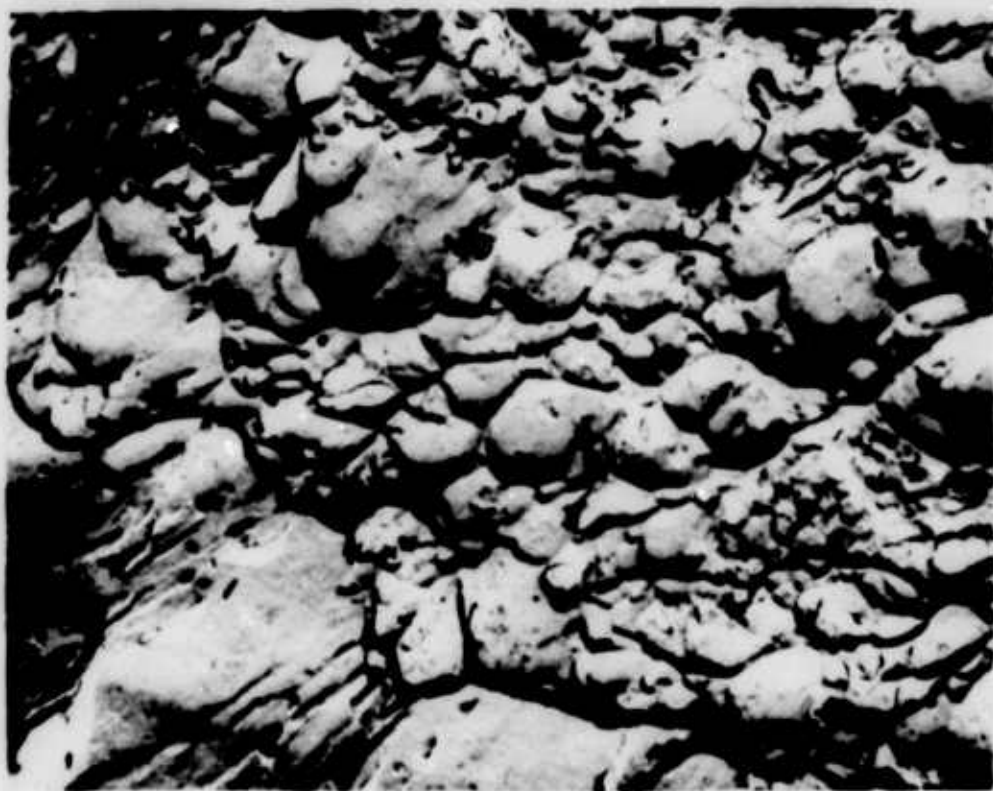
FIGURE 58
Electron Micrograph of Ductile Fracture Failure
4340 260,000-280,000 psi Heat Treat Strength Range
7800X

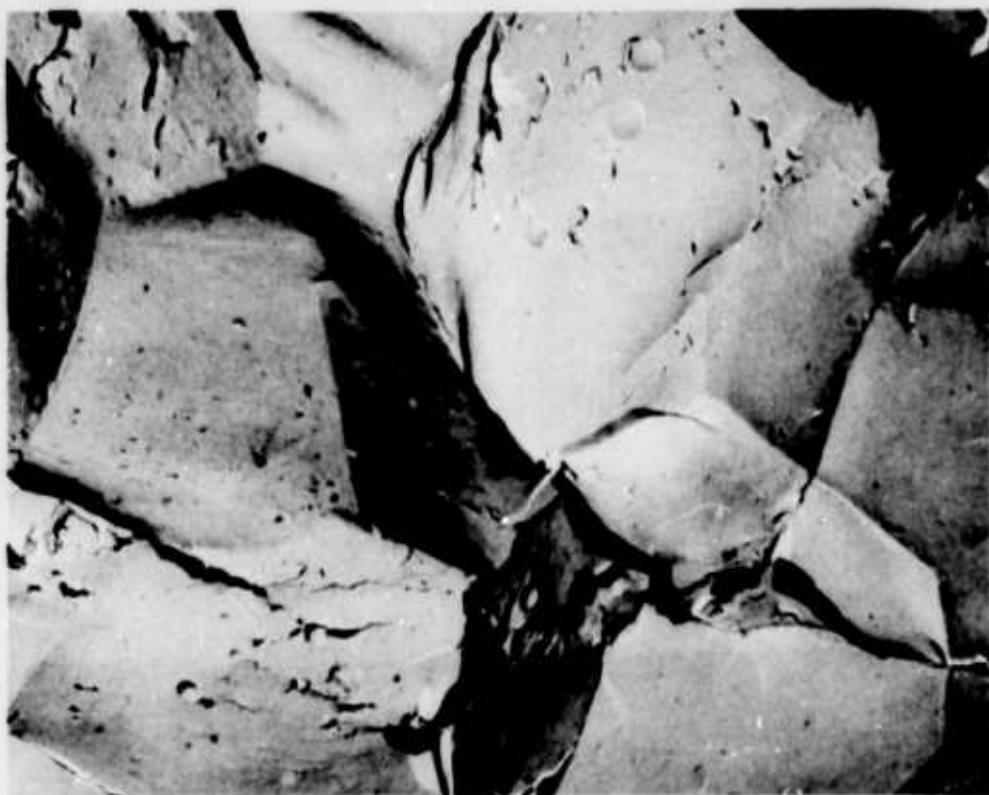
FIGURE 59
Electron Micrograph of Quench Crack Fracture Face.
4340 Water Quenched from 1575°F
4200X

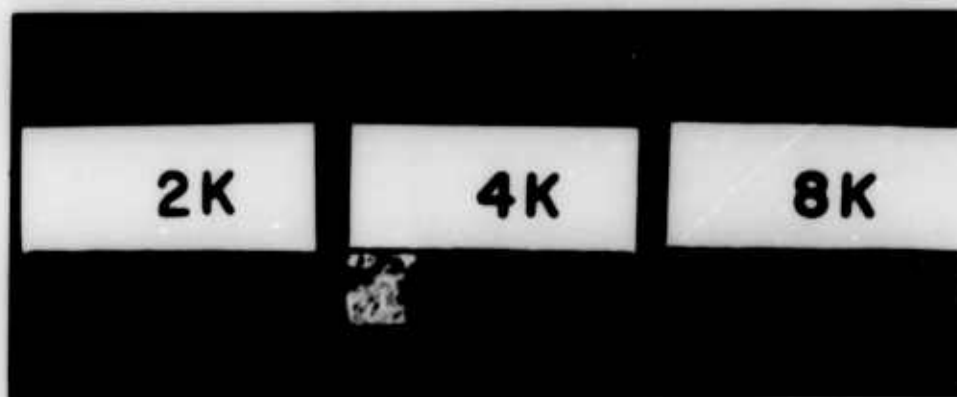
FIGURE 61
Fracture Faces of 4340 (Billet K, Oil Quenched) Specimens
275,000 psi Strength

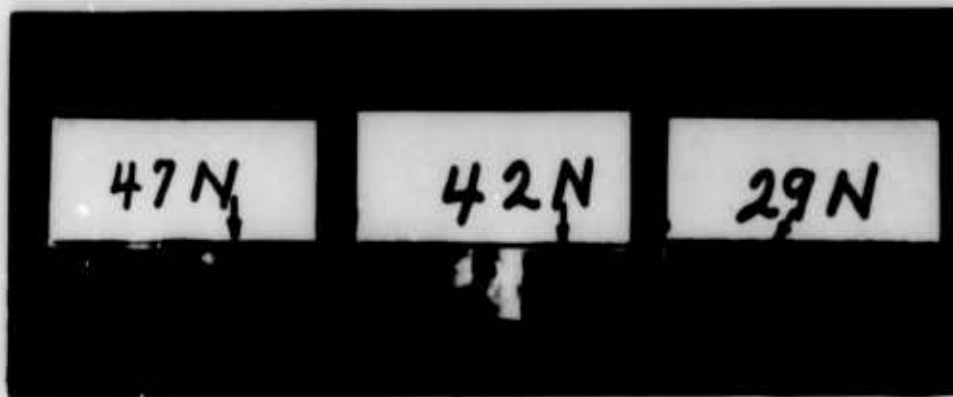
FIGURE 63
Fracture Faces of Painted and Cadmium
Plated Specimens. Arrows Indicate Failure Origins
275,000 psi Strength

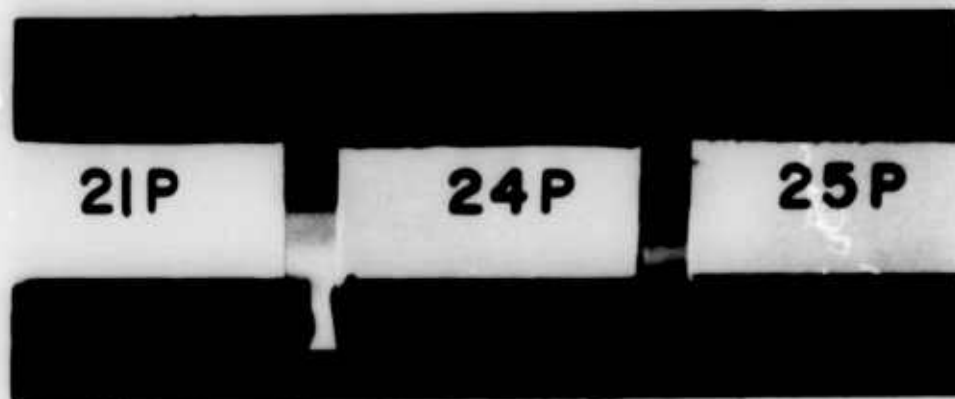
FIGURE 66

Fracture Faces of Low Strength 4340M (Billet P)
Specimens 250,000 psi Strength

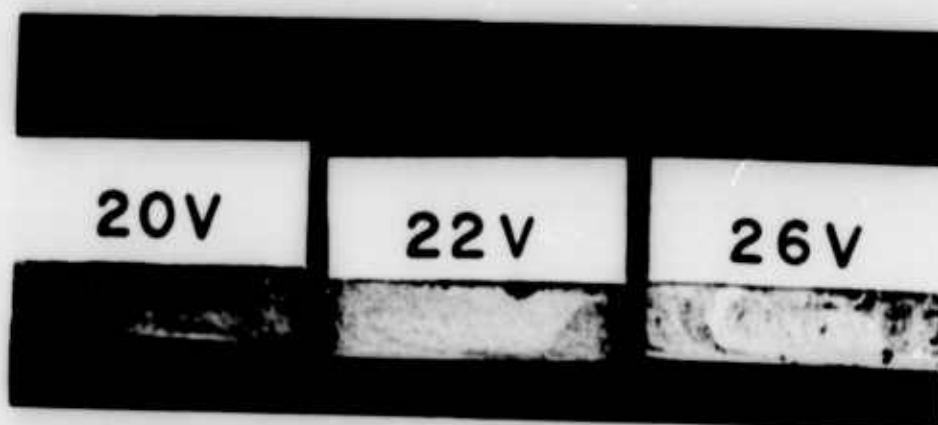
FIGURE 67

Fracture Faces of H-11 (Billet V) Specimens
306,000 psi Strength

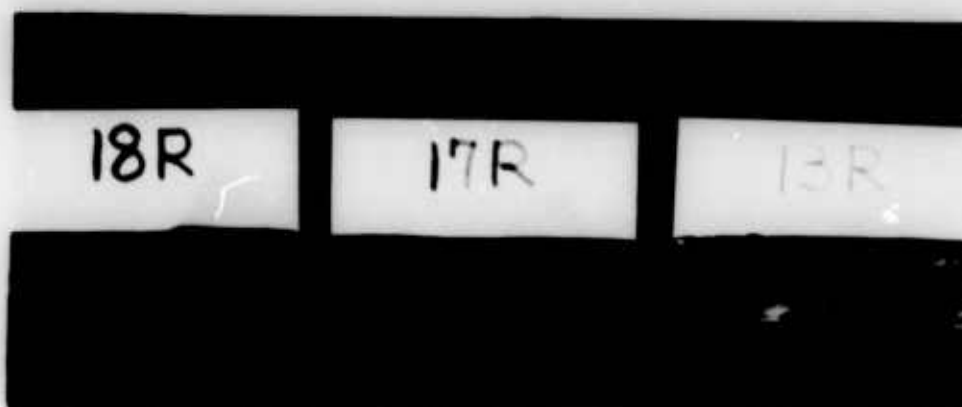
FIGURE 68

Fracture Faces of 4330 (Billet R) Specimens
227,000 psi Strength

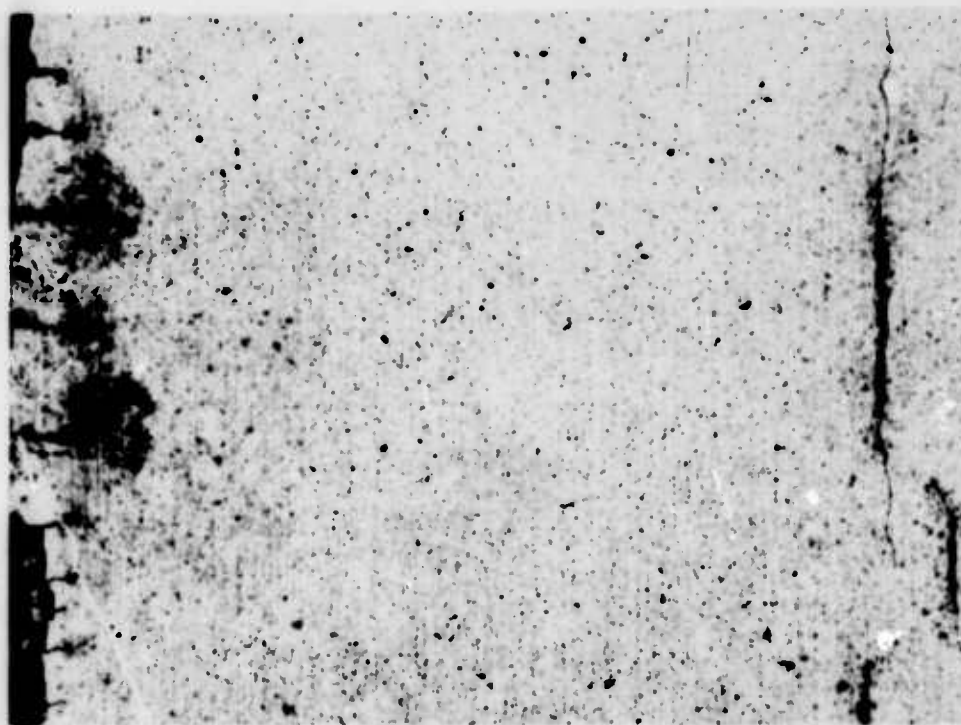
FIGURE 69

Cracking on Tension Surface of Failed H-11 (Billet V) Steel Specimen. Similar Cracking was Found on Other Low Alloy Steel Samples. Surface Revealed by Lightly Polishing and Macroetching in 50% HCl. 10X

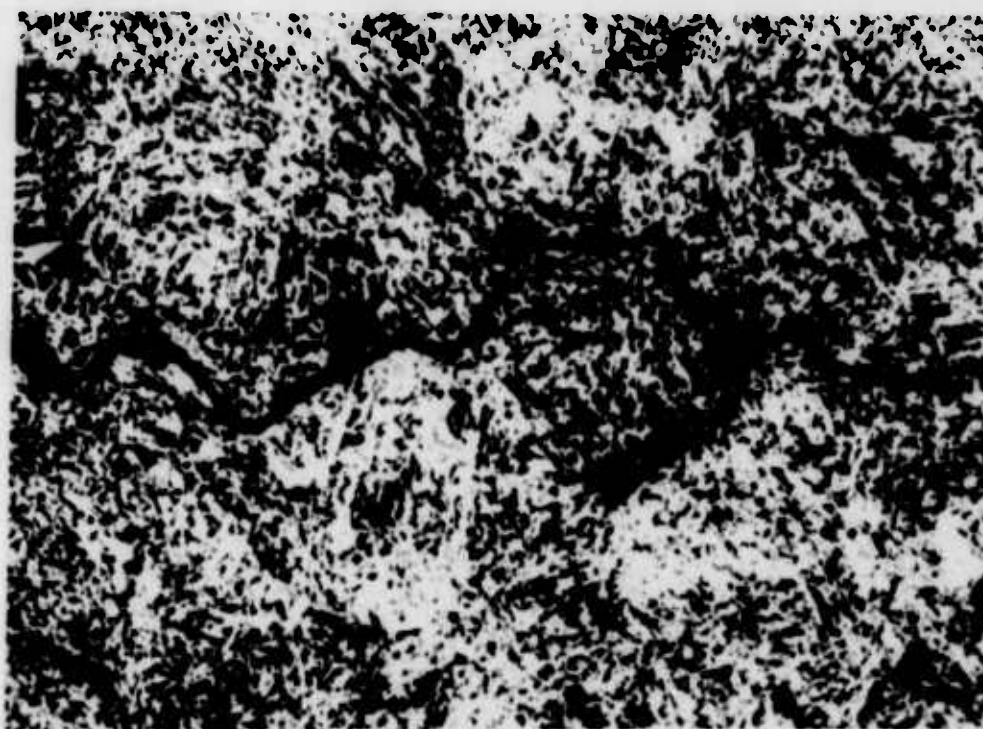
FIGURE 70

Stress Corrosion Cracking in 4340 Heat Treated to 240,000 psi Strength. Picral plus Cu Cl₂ 750X

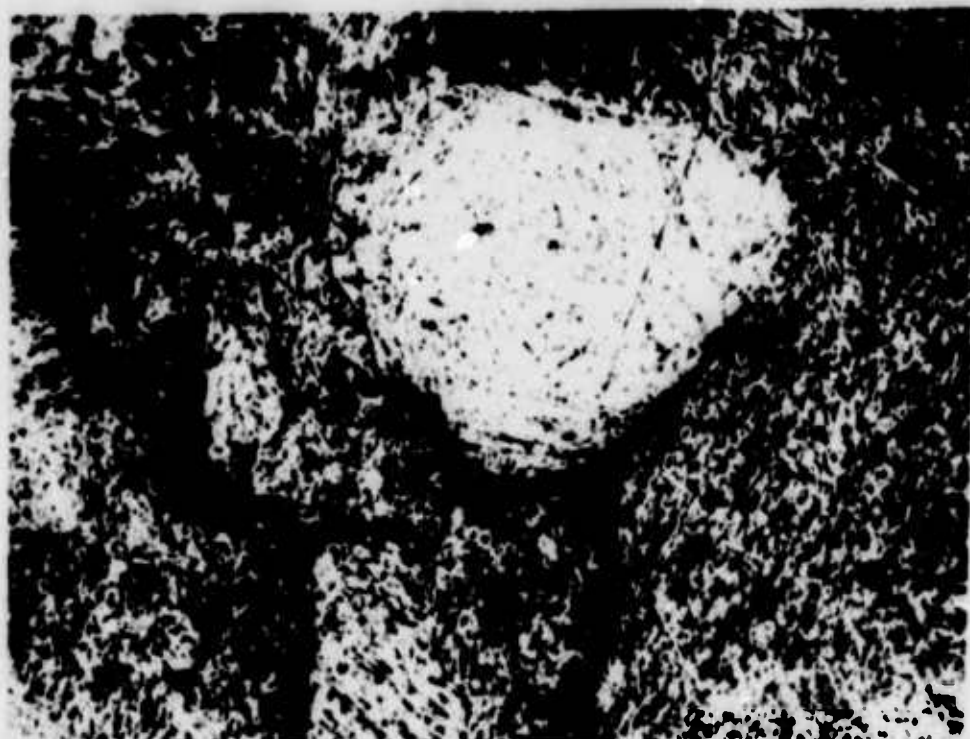
FIGURE 71
Stress Corrosion Cracking in 4340M
Heat Treated to 290,000 psi Strength
Picral plus Cu Cl₂ 750X

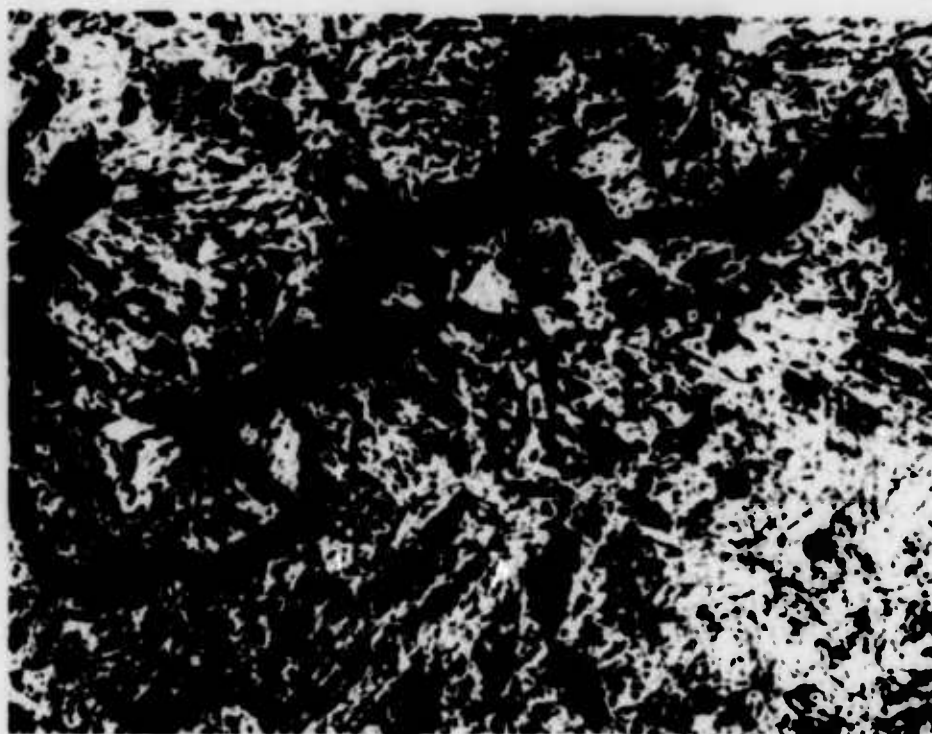
FIGURE 72
Stress Corrosion Cracking in 4330M
Heat Treated to 227,000 psi Strength
Picral plus Cu Cl₂ 750X

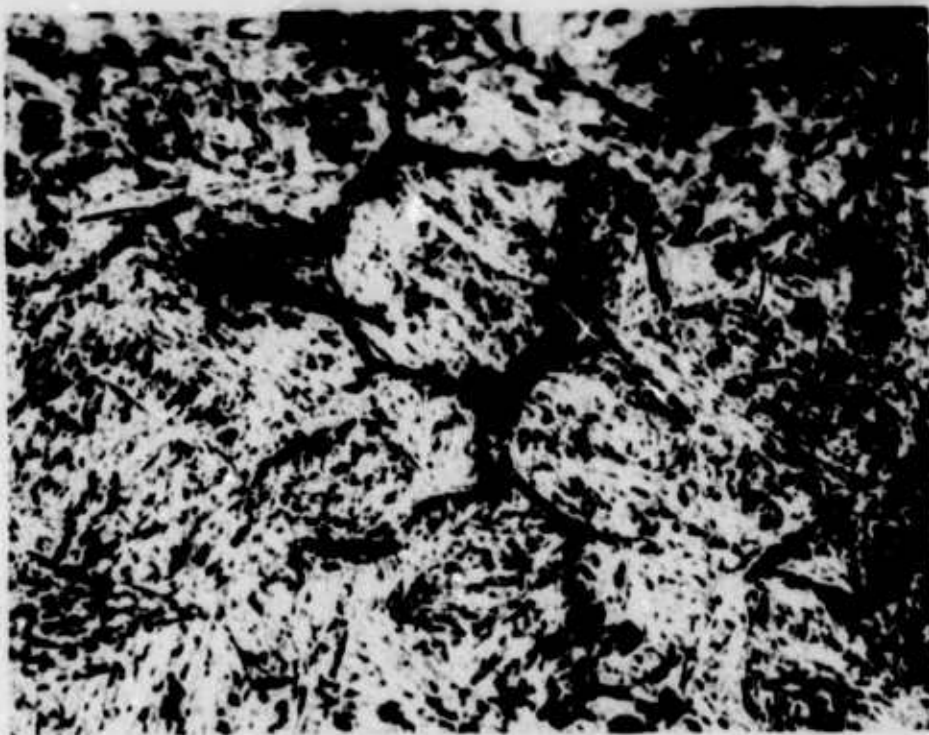
FIGURE 73
Stress Corrosion Cracking in H-11
Heat Treated to 293,000 psi Strength
Picral plus Cu Cl₂ 750X

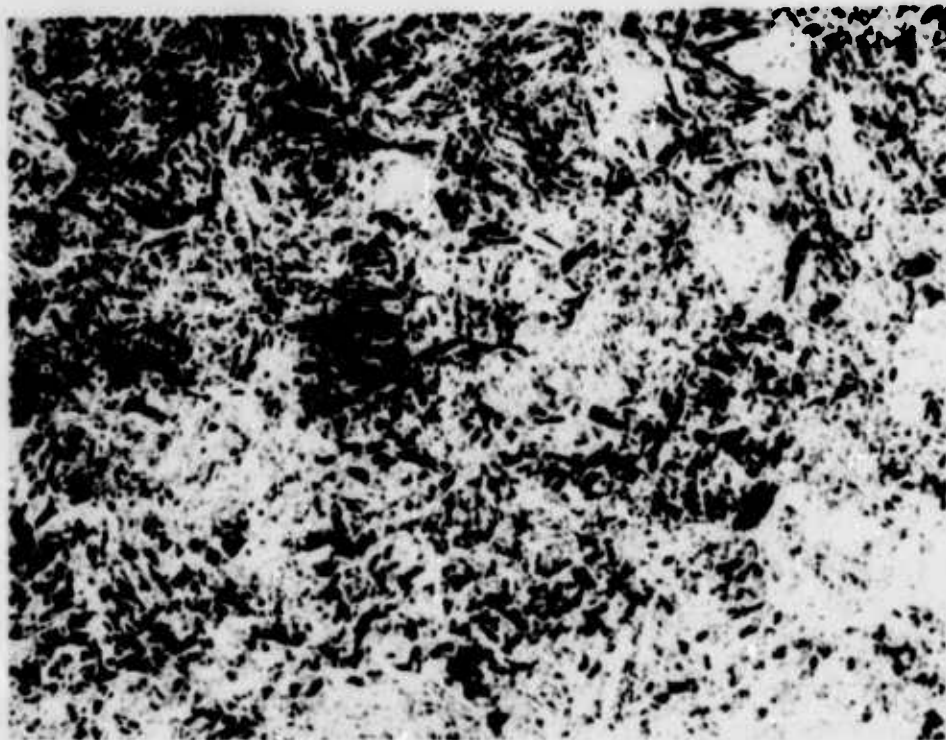
FIGURE 75
Crack Originating From Inclusion Pit and
Traveling Parallel to Fracture Face Nital 500X

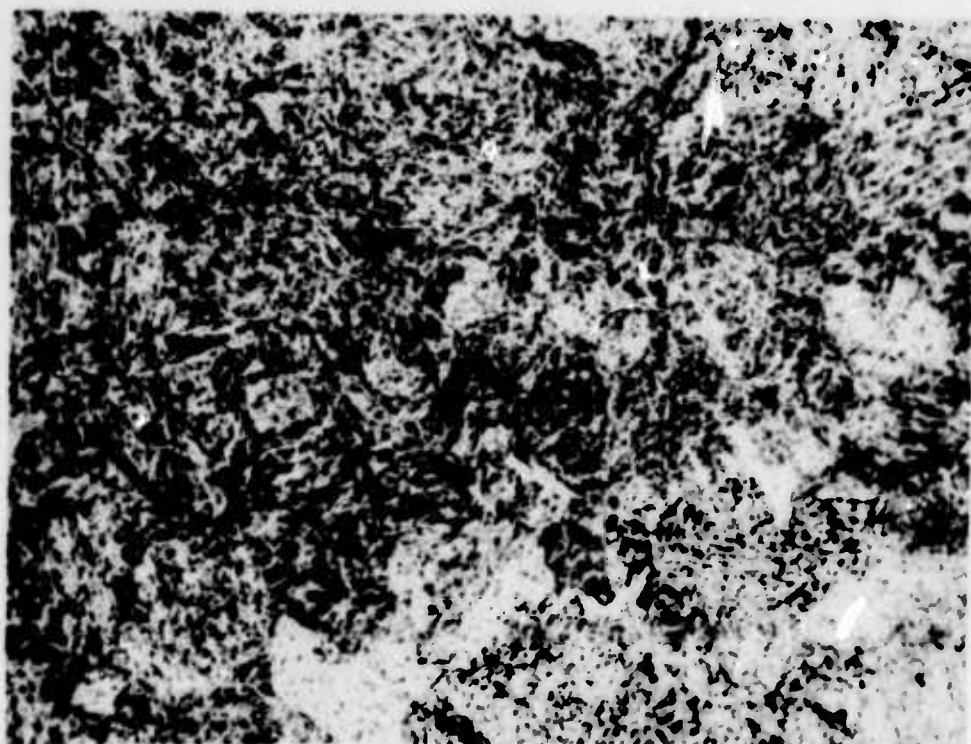
FIGURE 76
Microstructure of 4340 (Billet K) Heat Treated to
174,000 psi Strength Cu Cl₂ 400X

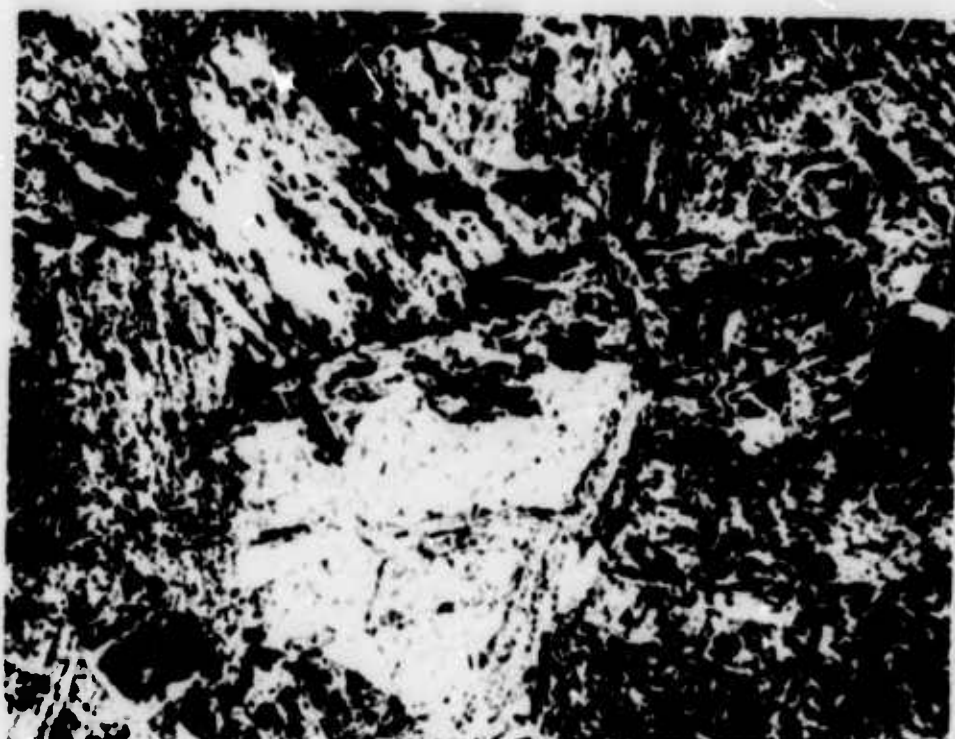
FIGURE 77
 Microstructure of 4330M (Billet R)
 Heat Treated to 188,000 psi Strength. Picral plus Cu Cl₂
 750X

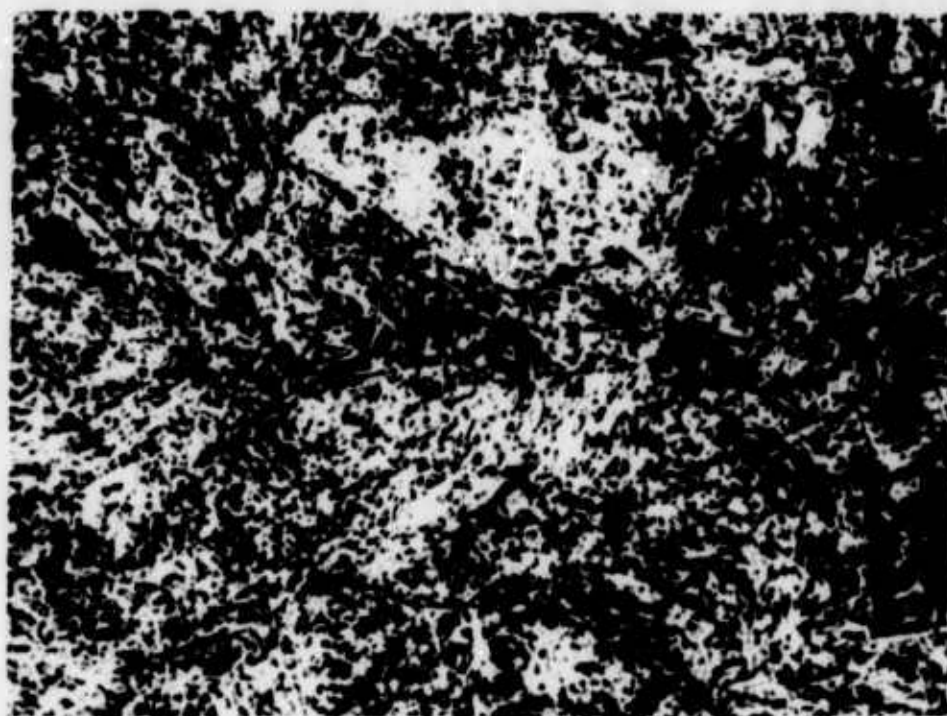
FIGURE 78
 Microstructure of H-11 (Billet V) Heat Treated to
 235,000 psi Strength. Picral plus Cu Cl₂
 750X

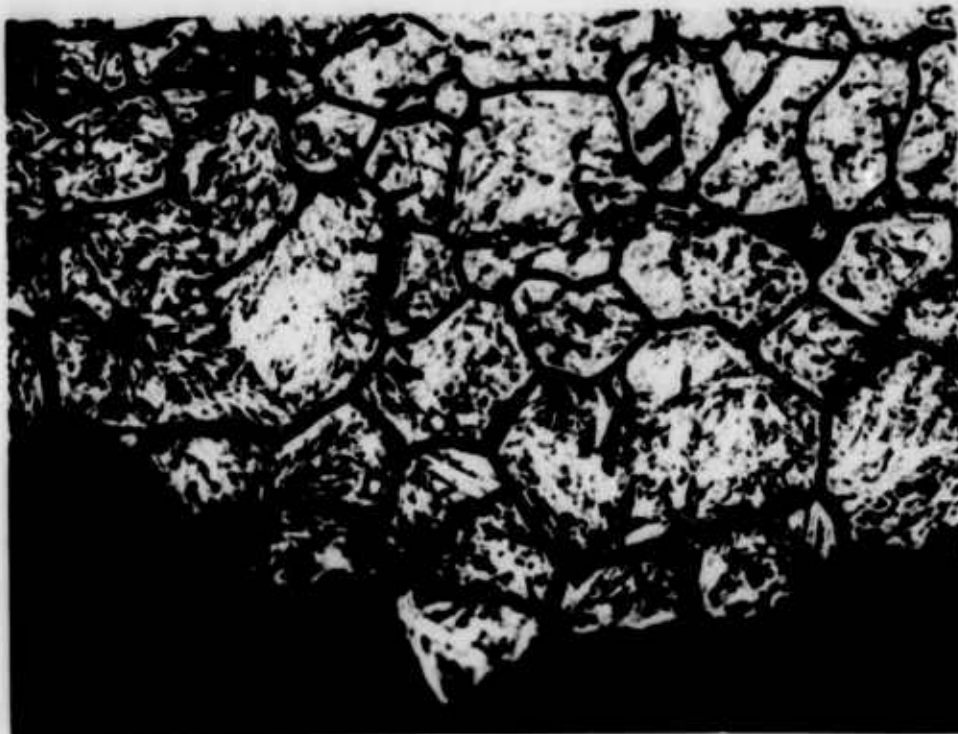
FIGURE 80
Microstructure of AM 355 Plate Near Fracture Origin
Ammonium Persulphate 400X

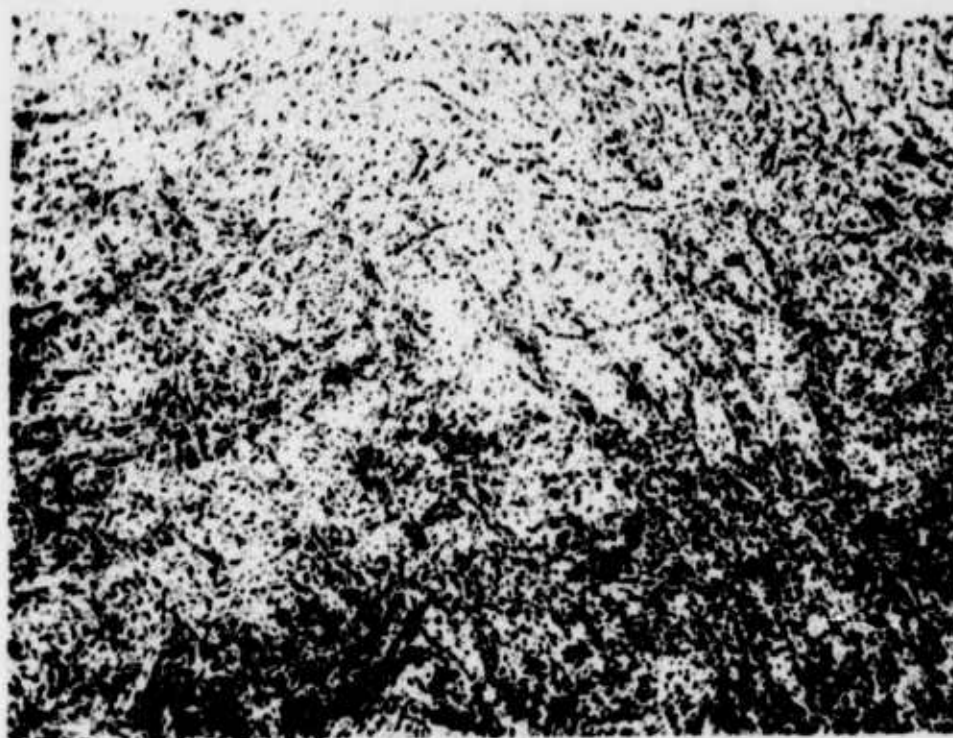
FIGURE 81
AM 355 Billet Material Heat Treated to the SCT 850
Condition Using Standard Procedure. Ammonium Persulphate
400X

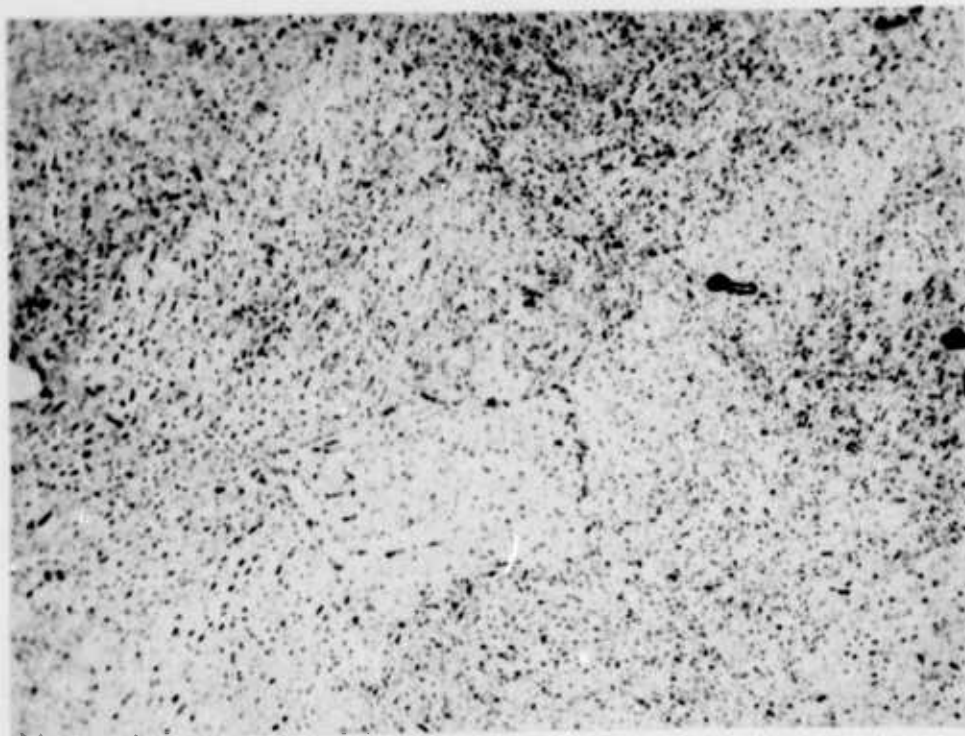
FIGURE 82
AM 355 Billet Material Heat Treated to the SCT 850 Condition
Using Modified Procedure. Ammonium Persulphate 400X

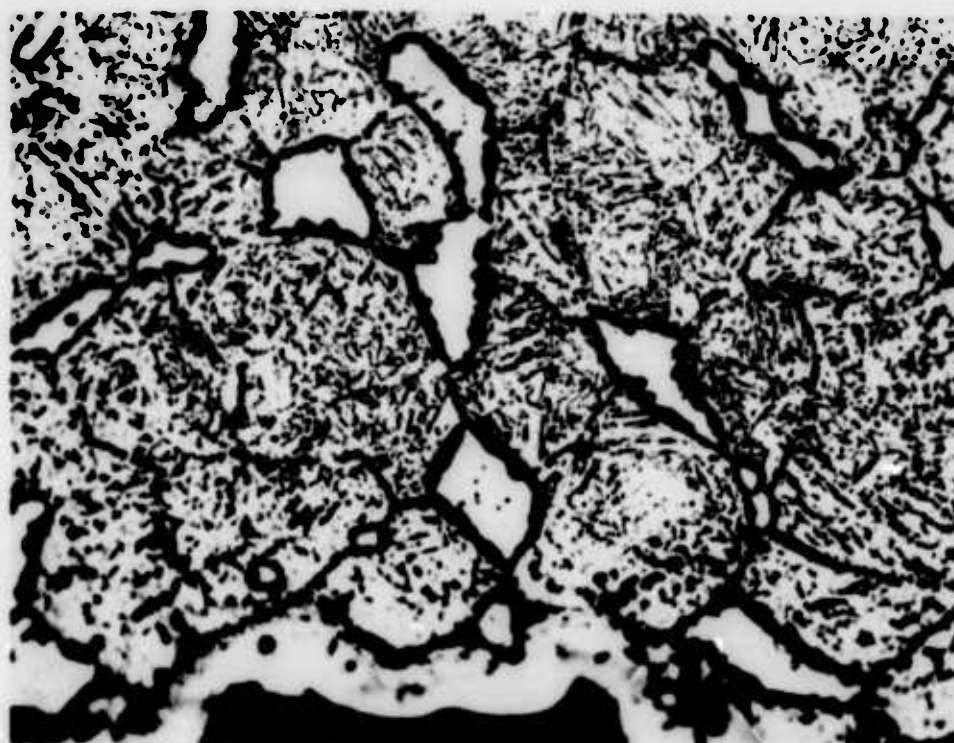
FIGURE 84
Microstructure of AM 350 SCT 850 Specimen 3Y Near
Fracture Origin. White Areas are Delta Ferrite
Ammonium Persulphate 400X

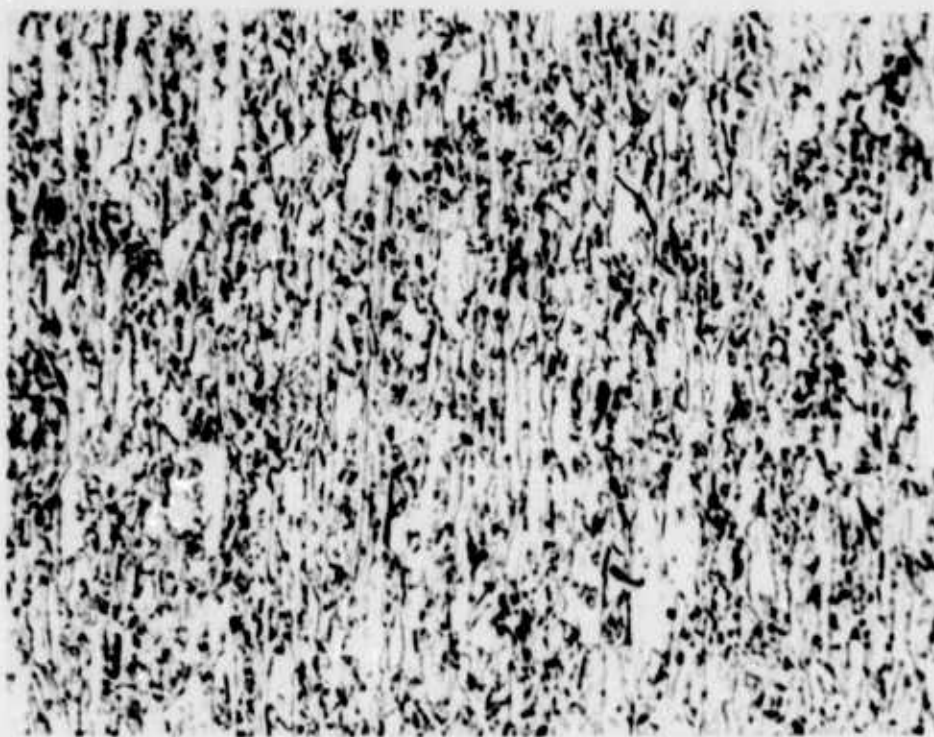
FIGURE 88
Microstructure of AM 350 CRT 850
0.060" Sheet in the Longitudinal Grain Direction
Ammonium Persulphate 400X

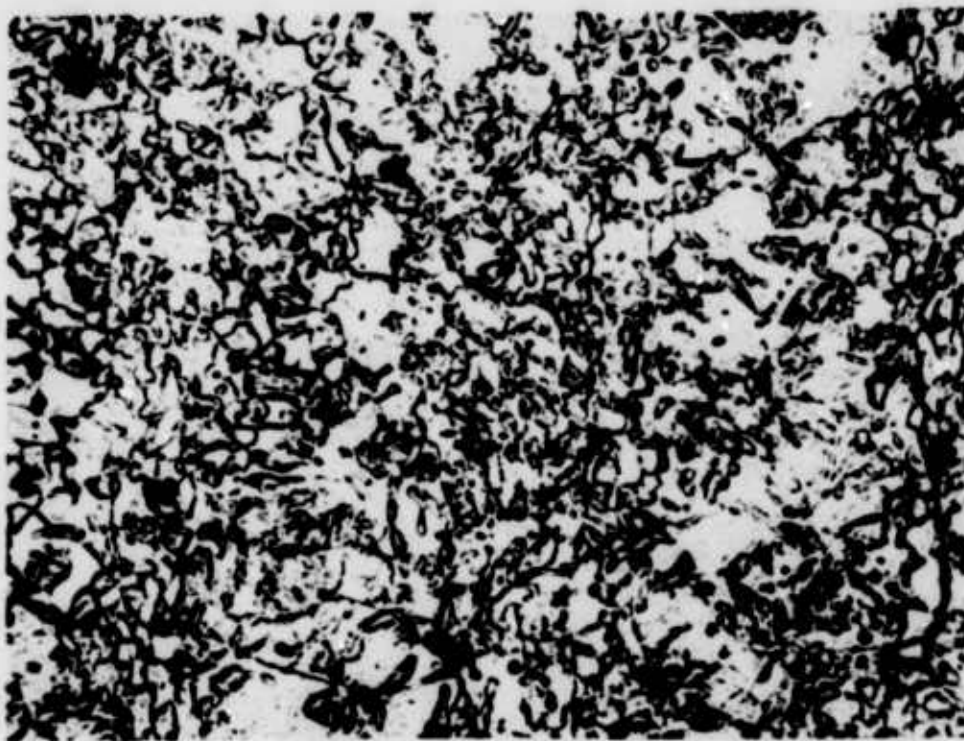
FIGURE 89
Microstructure of AM 350 CRT 850
0.060" Sheet in the Transverse Grain Direction
Ammonium Persulphate 400X

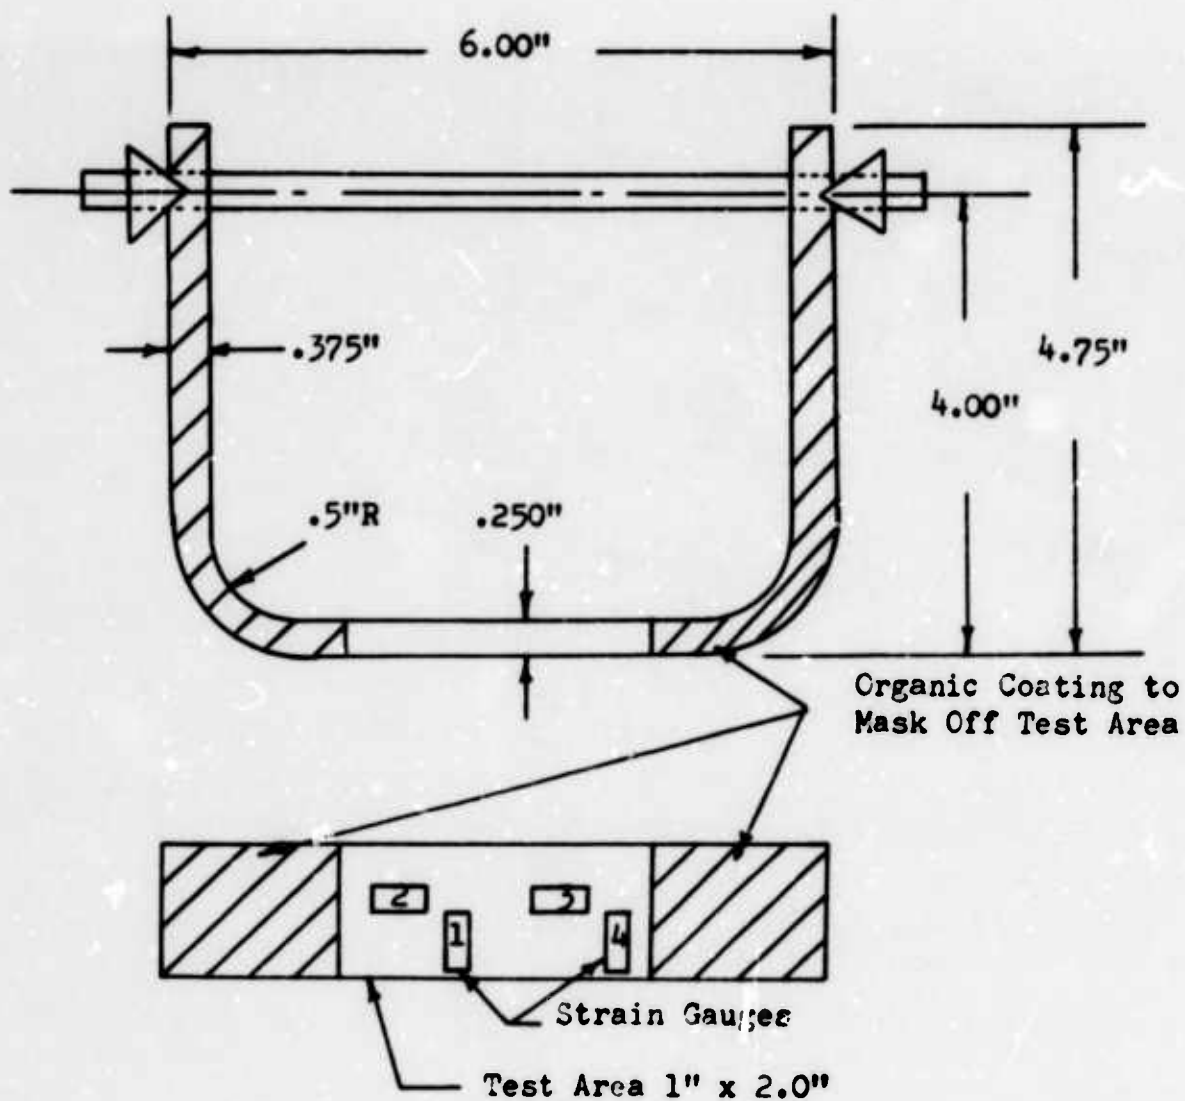
FIGURE 100. U-Type Stress Corrosion Specimen Showing Strain Gauge Locations
